# **Exhibit B**

Before LaForce remediation photos

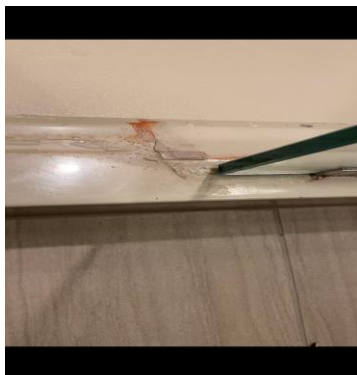
Room 1801.jpg

**Room #1801 - missing screws**

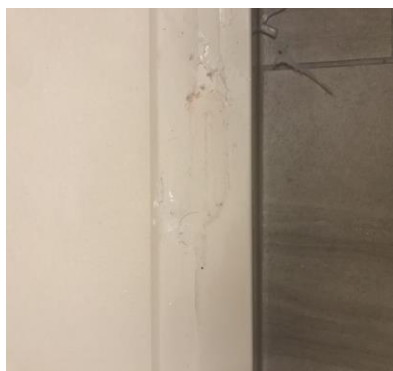
Room 2053.jpg

**Room #2053 - door barely in guide**
